**DEPARTMENT OF TRANSPORTATION**

Contract #: 04-0120F4Cty: SF/ALA Rte: 80 PM: 13.2/13.9File #: 1.28**WELDING INSPECTION REPORT****Resident Engineer:** Casey, William**Address:** 333 Burma Road**City:** Oakland, CA 94607**Report No:** WIR-026735**Date Inspected:** 18-Nov-2011**Project Name:** SAS Superstructure**OSM Arrival Time:** 700**Prime Contractor:** American Bridge/Fluor Enterprises, a JV**OSM Departure Time:** 1530**Contractor:** American Bridge/Fluor Enterprises, a JV**Location:** Jobsite**CWI Name:** As noted below**CWI Present:** Yes No**Inspected CWI report:** Yes No N/A**Rod Oven in Use:** Yes No N/A**Electrode to specification:** Yes No N/A**Weld Procedures Followed:** Yes No N/A**Qualified Welders:** Yes No N/A**Verified Joint Fit-up:** Yes No N/A**Approved Drawings:** Yes No N/A**Approved WPS:** Yes No N/A**Delayed / Cancelled:** Yes No N/A**Bridge No:** 34-0006**Component:** SAS OBG**Summary of Items Observed:**

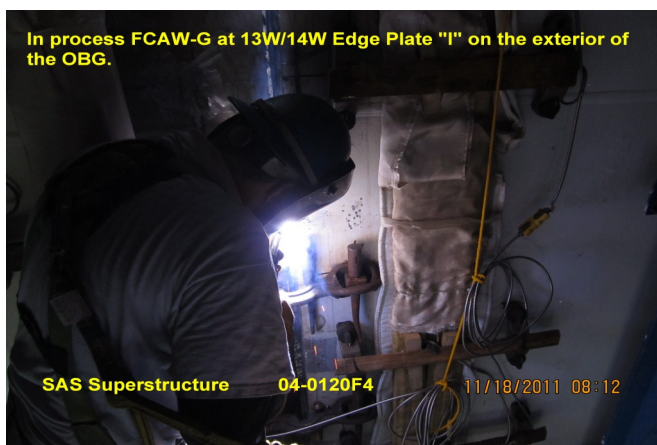
This QA Inspector randomly observed ABF welder Richard Garcia (ID 5892) on diagonal plate "I" at 13W/14W performing the Flux Core Arc Welding w/Gas (FCAW-G) process in the (3G) vertical position. The 25 mm depth of the B-U2a-GF joint was pre-heated from the interior of the OBG and QC Inspector William Sherwood verified that the preheat temperature was at the minimum of 200 degrees F. This QA Inspector observed the QC Inspector monitoring the welding to ensure that the parameters (A=245/V=23.3/TS=150/HI=2.28) were in accordance with ABF-WPS-D1.5 -3040B-3. The welding parameters observed at this location appeared to be in general compliance with the contract specifications.

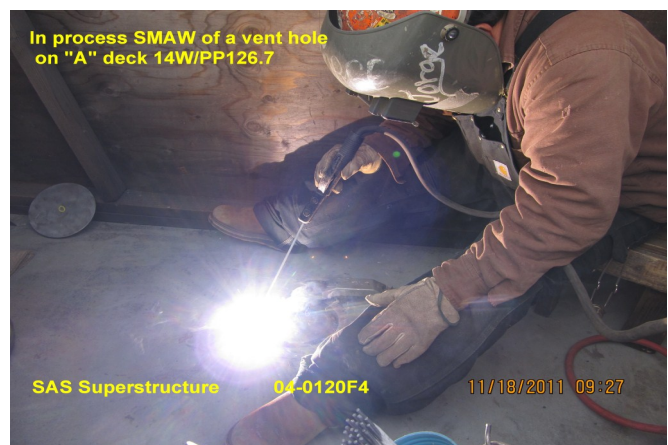
This QA Inspector observed QC Inspector Sal Merino perform joint fit-up operations on an "A" deck vent hole on the exterior of the OBG located at 14W/PP126.7/W2.8. This QA Inspector verified the B-U-4a complete Joint penetration (CJP) fit-up and found it to be satisfactory and in conformance with the welding procedure. This QA Inspector randomly observed ABF welder Mike Jimenez (ID 4671) pre-heat the complete joint penetration (CJP) vent hole to 10°C prior to performing SMAW in the (1G) flat position. This QA Inspector observed the QC Inspector monitoring the inter-pass temperatures and the welding to ensure the parameters were in compliance pertaining to ABF-WPS-D15-1050A-CU. The parameters were recorded as (Amperes=146) utilizing a 3.2 mm E7018-H4R electrode. This QA Inspector randomly observed the ABF welder grind and blend the start and stop areas of the weld throughout the joints depth. This QA Inspector made subsequent observations throughout the shift to monitor quality and noted that the work was completed on this date and appeared to be in general conformance with the contract specifications.

This QA Inspector observed QC Inspector Sal Merino utilize a Bridge Cam Gage to measure the fit-up of the 20 mm plate in the B-U-4a joint on vent hole 14W/PP126.7/W4.2. This QA Inspector verified the fit-up as acceptable and employed a 65°C Tempilstik to ensure the minimum pre-heat temperature had been achieved. This QA Inspector randomly observed ABF welder Jorge Lopez (welder ID 6149) performing the Shielded Metal Arc Welding (SMAW) process in the (1G) flat position and observed the QC Inspector verify the welding parameters were in accordance with the above mentioned WPS. This QA Inspector made subsequent observations throughout the shift to monitor quality and noted that the work was completed on this date and appeared to be in general compliance with the approved WPS and the contract specifications.
